LANDSLIDES AND RELATED FEATURES

OF THE ERNEST, PA. QUADRANGLE

by
John S. Pomeroy
1979

OPEN FILE MAP 79-1314 (F-7)

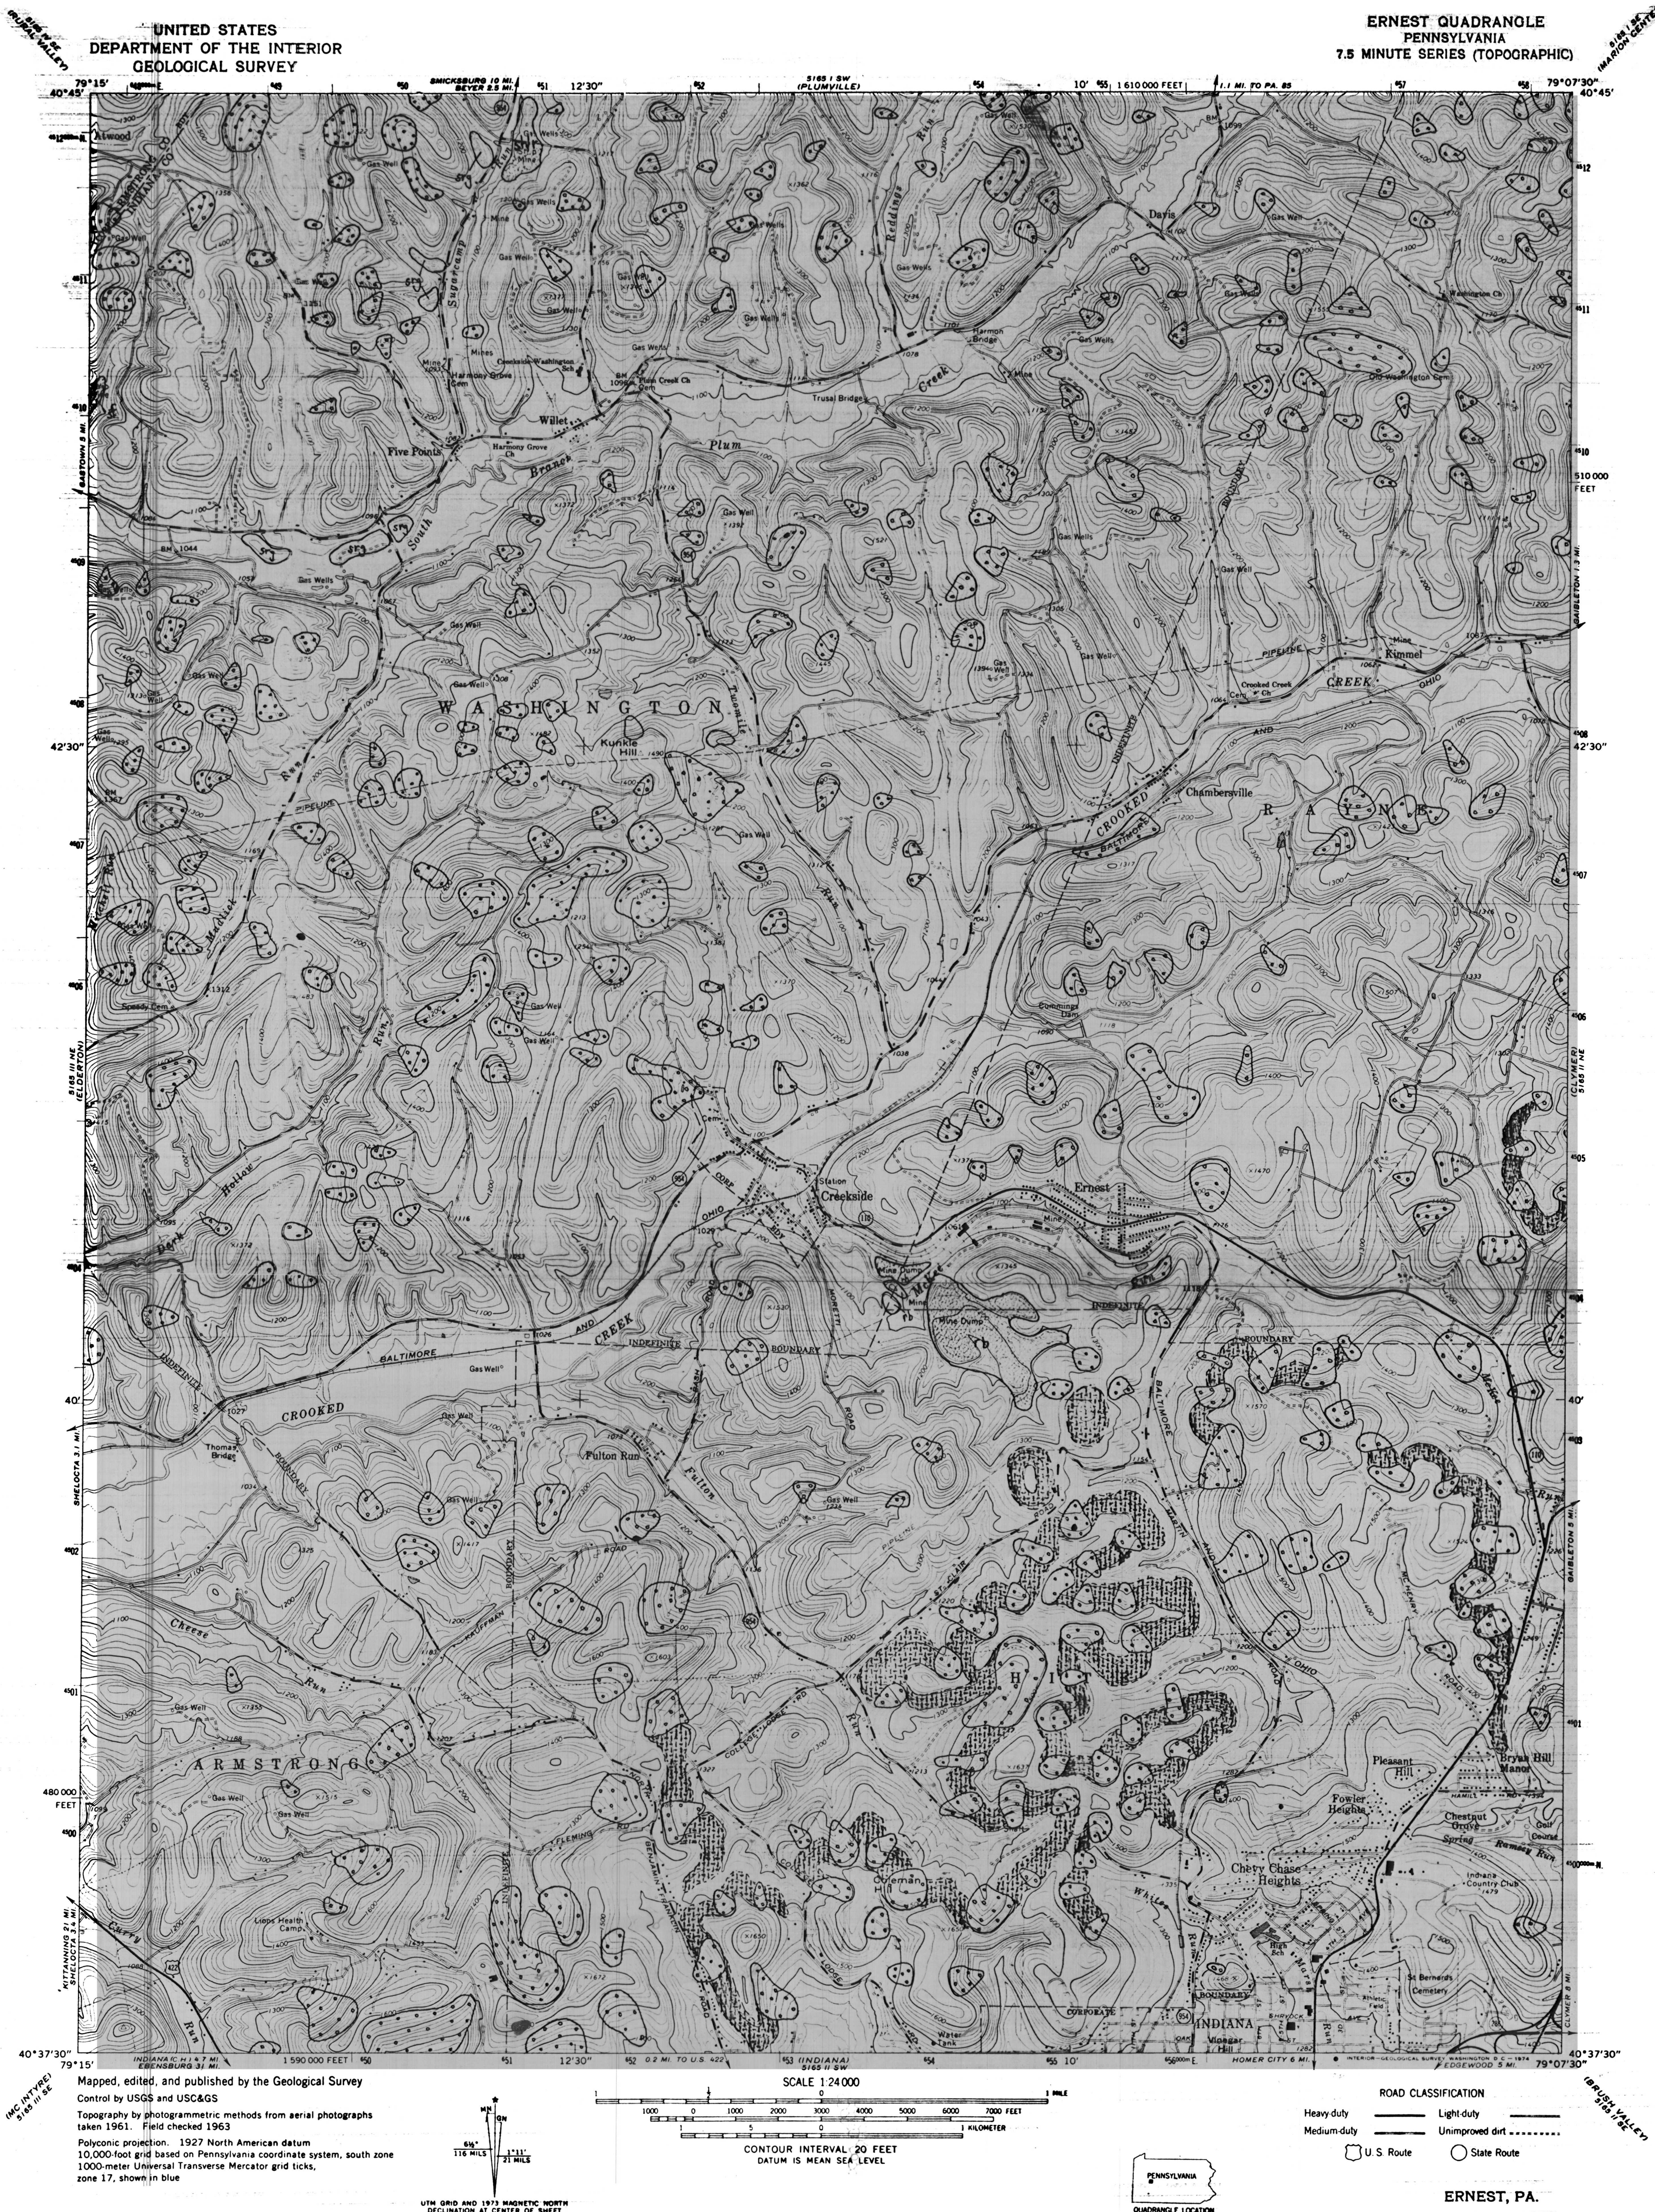
ACTIVE OR RECENTLY ACTIVE LANDSLIDE
Complex landslide composed of earthflow, debris slide, earth and rock slump. Identified from historical records, and from scars, debris and other field evidence. Ground extremely unstable; sliding accelerated by excavation, loading and changes in drainage conditions. May include areas with several active slides too small to be shown separately. Questioned where doubtful.

OLD LANDSLIDE
Area of extensive hummocky ground caused by earthflow and earth and rock slump. Lacks clear evidence of active sliding. Relatively stable in natural, undisturbed state, generally not affected by small structures properly sited in areas away from the edge of the toe; can be reactivated by extensive, rapid excavation, loading, and changes in ground water and surface water conditions. Area of old landslide probably includes recent ones not identified from field evidence or otherwise documented. Upslope boundary of landslide generally defined by modified scarp, but downslope (toe) may be gradational and not well defined. Questioned where doubtful.

COMBINATION LANDSLIDE
Area of recent and old slides in which individual slides are not identified.

COLLUVIAL SLOPE
Valley wall along major streams with slope as steep as 40° (85%); stony, clayey silt soil up to 50 ft. (15 m) thick; commonly buttressed by a terrace or bench at the toe of the slope; very susceptible to sliding by cutting of toe area, removal of terrace or bench, and overloading; slide commonly activated without apparent cause.

SCREE
Residual accumulations of coarse rock material lying on quartzite slopes of the Valley and Ridge province. Generally stable except where subjected to extreme rainfall.

COLLUVIAL SLOPES WITH LANDSLIDES
Landslides too small or obscure to map individually.

AREAS SUSCEPTIBLE TO DEBRIS FLOWS AND DEBRIS AVALANCHES
Primarily shallow, narrow ravines and chutes with accumulation of stony colluvium generally 10 ft. (3 m) or less in thickness; susceptible to rapid movement during intense rainfall. Most ravines and chutes designated show evidence of former debris flows and avalanches. Symbol & designates historical debris flow or debris avalanche.

AREAS SUSCEPTIBLE TO ROCKFALL
Steep, locally vertical, natural and man-made slopes and cliffs, 15 ft. (4.5 m) or more high; formed dominantly of sandstone, limestone, sandy shale, mudstone and claystone. Interbedded mudstone, claystone and shale weather rapidly leaving sandstone and limestone rock faces unsupported.

SOIL AND ROCK SUSCEPTIBLE TO LANDSLIDING
Soil and rock similar to that involved in landslides elsewhere in map area; primarily areas underlain by claystone, mudstone and shale associated with other rock types. Rock weathers rapidly on exposure forming clayey soil highly susceptible to sliding. Includes cohes (U-shaped, shallow valleys) containing thick layers of clayey soil that are very susceptible to sliding where excavation breaks continuity of slope and where overloaded by artificial fill.

AREAS LEAST PRONE TO LANDSLIDES
Map areas in which no patterns or symbols are shown; primarily valley floors, ridge tops and broad benches; modification by excavation and fill may lead to local landslides. Includes slopes where landslides are sparse.

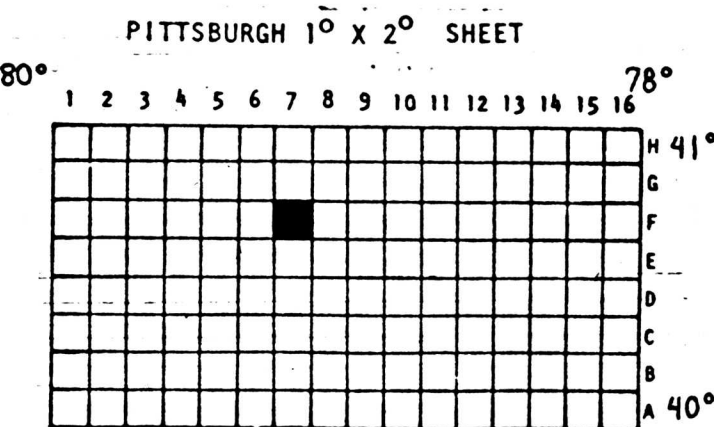
The first five digits of the open file number designate the specific 1:250,000 scale map sheet of which this quadrangle is a part. The last two digits designate the position of the quadrangle in a subdivision of the 1:250,000 scale map based on rows and tiers shown in the diagram to the right. The location of this quadrangle is shown by the black square.
